PRCI Co-sponsored Long-term Composite Repair Study Year 0 Burst Test Progress Report (December 2008)

Prepared by: Chris Alexander (chris.alexander@stress.com and 281-897-6504)
 Prepared for: EMS Group (10-year study participant)
 Subject: Test results for Year 0 burst test involving 12.75-inch x 0.375-inch, Grade X42 pipe. Composite repair of three samples having corrosion depths of 40, 60, and 75% relative to nominal pipe wall thickness.

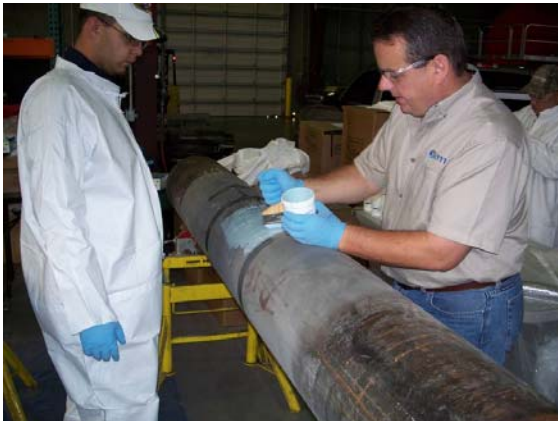
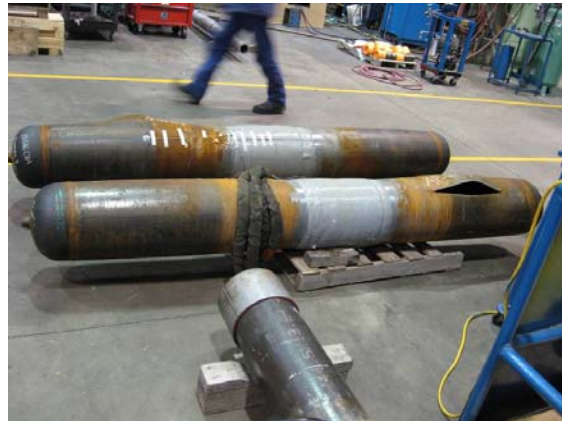
Photographs

All burst test failures occurred outside of the repairs. The recorded strain gage readings were relatively low and would be considered acceptable for design conditions.

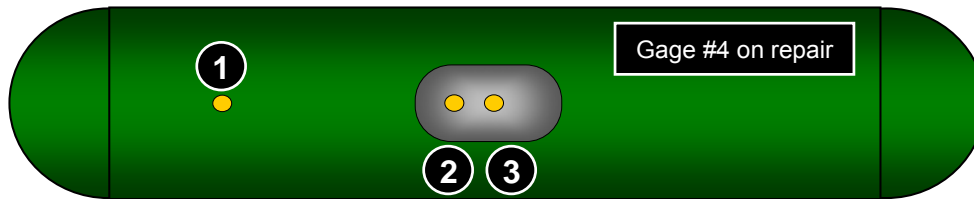
Figure 1 – Details on strain gage installation

- The pressure levels for the pipe are MAOP = 1,778 psi and SMYS = 2,470 psi.
- Refer to **Figure 1** on the attached page for the strain gage locations. Gage #4 on the outside of the repair is lined up with Gage #3 on the machined corrosion region.
- The strain gage results are in units of microstrain ($\mu\epsilon = 10^{-6}$ in/in). Elastic stress is calculated by multiplying strain by the material's elastic modulus (i.e. 30 Msi for steel). For example, if the strain in the steel is 1000 $\mu\epsilon$, the stress is calculated to be 1000 $\mu\epsilon \times 30$ Msi = 30,000 psi. For the composite material, the elastic modulus will be less than steel.
- The measured composite thickness values for the 40, 60, and 75 percent samples were 0.530, 0.655, and 0.775 inches, respectively.

Location of strain gages installed on the test sample

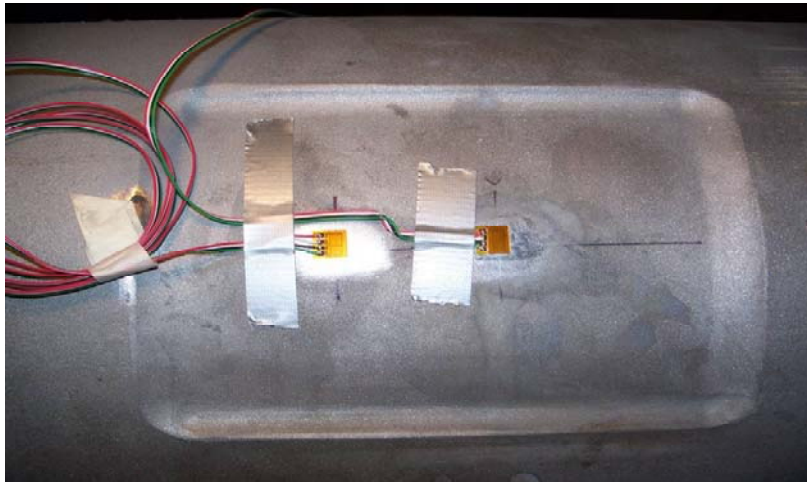
Photograph of strain gages installed in a machined corrosion region
